ACCU Nara International Correspondent WII7 2017 The Seventeenth Regular Report

The ACCU correspondents periodically send reports on cultural heritage protection activities in which they have been recently involved. This is a collection of fifteen reports submitted by international correspondents in the Asia-Pacific region.

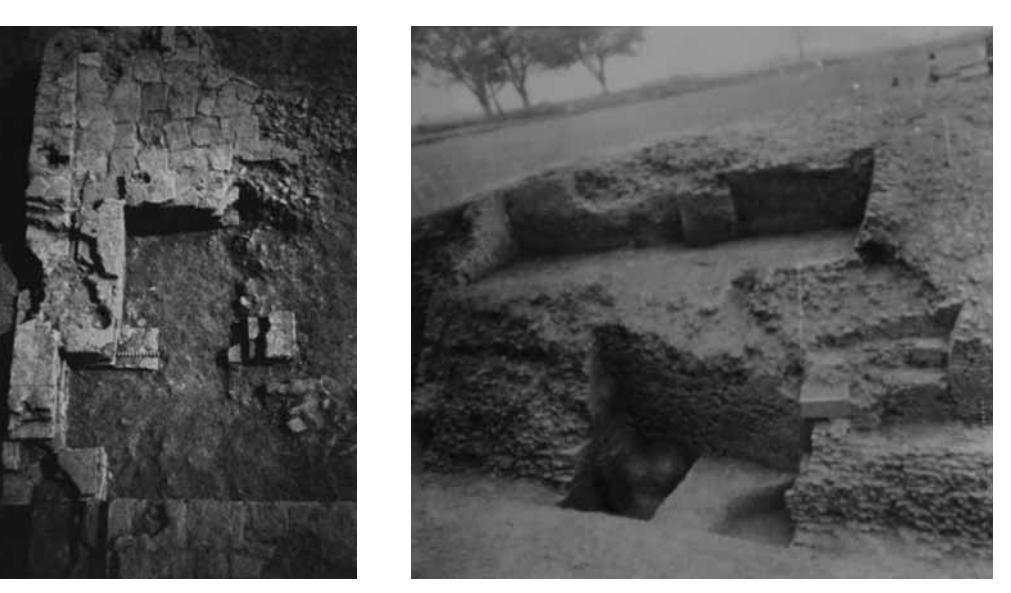
Excavation at Mahasthangarh in 1993-1999

Archaeological excavation started here at 23.80 m above sea level and deep sounding excavation was conducted up to the virgin soil. A total of 50 samples were collected for radiocarbon dating from the different layers excavated by both teams (Alam and Salles 2001). Level 1: NBPW was mainly found on Building Levels 1 and 1B (lowest layer) and these items had been created and used in the late 4th century BC. Level 2: Mostly NBPW with some Rouletted Ware and Red Polished Ware were found from Level 2. Level 3: Again mainly NBP Ware with some rouletted shards found on Building Level 3. Level 4: Only some NBPW obtained from Building Level 4. Level 5: Again mostly NBPW was found on Level 5 along with terracotta plaques, terracotta animal figurines, small objects, stone and glass beads, and a rock crystal ring (Alam and Salles 2001:159).

Among the 18 Building Levels, NBPW was discovered from Building Levels 1 to 5, with their time period being

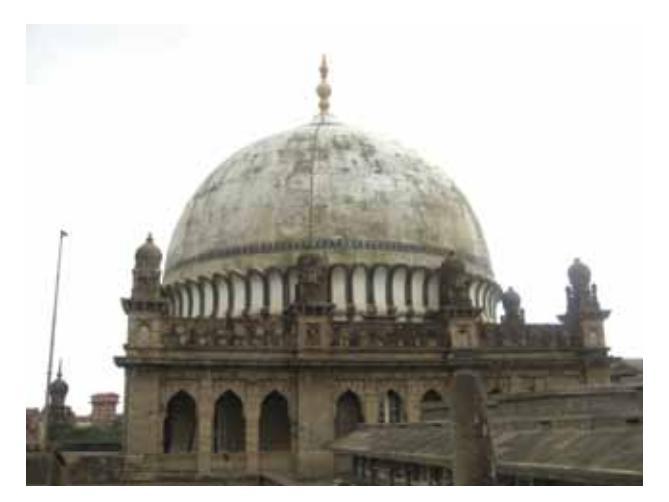
The discoloured main central dome with dust and grime deposits

The cement chemical membrane coating on the china mosaic of the main dome was removed by scraping and water washing with a non ionic detergent, followed by further scraping and cleaning with brass fine wire brushes.

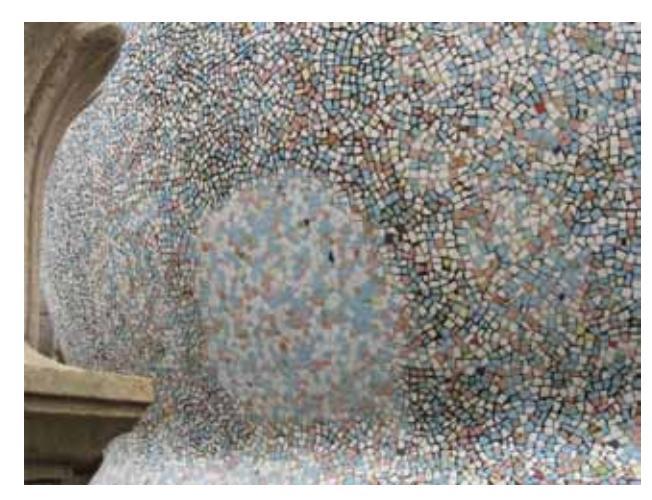
The China mosaic dome during the cleaning process

The process of removal of the membrane was repeated until the original shine of the china mosaic was seen, followed by rubbing dry white cement to bring back the original glaze. The small domes were grouted by drilling holes through the china mosaic surface of the dome up to the depth of the inner concrete base and fixing 12 mm diameter pipe nipples at 1 meter c/c staggered spacing in both directions with removable putty. Acrylic polymer grout mixed with white cement was used in a standard grout pump, with calibrations to avoid rupturing of the shell. The same procedure was followed to grout the flat terrace area also. All the drain-mouths on the terrace were

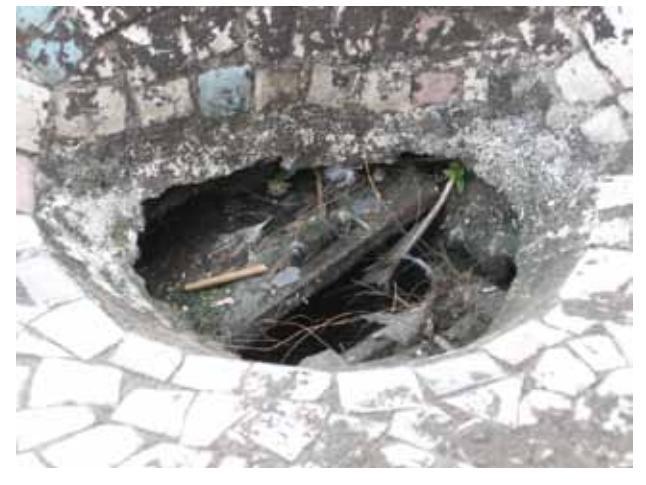
Clogged drain-mouths on the terrace surface that had prevented complete drainage of surface runoff rainwater

cleaned, the objects that had led to choking cleared, broken spouts replaced, and inner slopes corrected and protected by SS mesh.

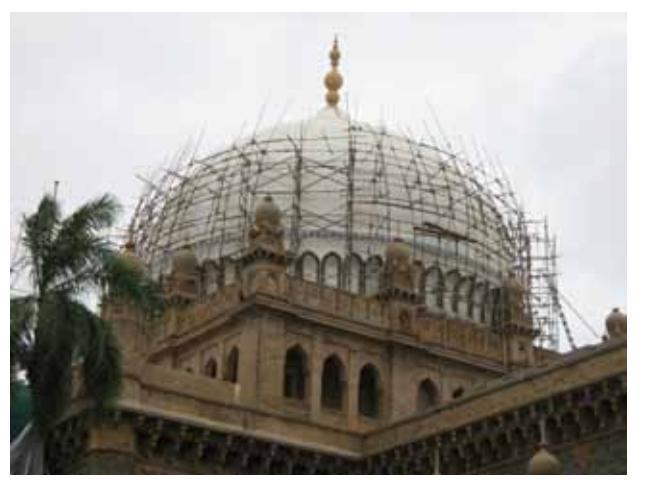
The original shine on the white dome after the non-abrasive and non-chemical cleaning process

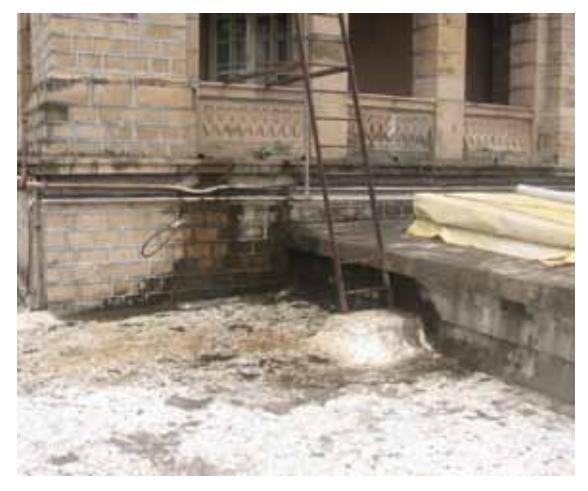
Leaking rainwater pipes and poorly managed storm water drainage on the terrace

The original rainwater drainage system was thoroughly inspected during monsoons to check for leakages and seepages as well as assess the functioning of the existing CI down-take pipe sections, and those found to be faulty or extensively corroded were to be replaced entirely or in part and along the bends. Faulty down-take pipes were causing moisture ingress in the masonry walls. The soil pipes were also to be replaced in part if there were any

damage or malfunctions found. New 100 mm diameter CI rainwater down-take pipe sections and soil pipes were fixed using MS clamps, screws and fixtures along specified locations including bends, and the joints were filled with lead. These were painted with primer enamel paint to match the stone color. Barbed wire was wound around the pipes and MS clamps were fixed, where missing, along all the rainwater and soil pipes.

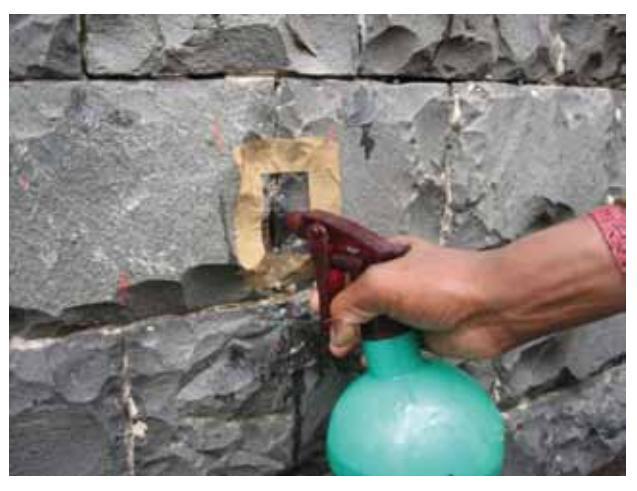
Removal of ficus growth and application of chemicals in the crevices to kill roots and prevent further growth

Ficus growth was found on the wall surfaces along the different components of the building, indicating defects in pointing and the presence of cracks and crevices in cornices and walls, brackets and other ornamental stone works. It was also proof of inadequate drainage of storm water. The plant growth was removed by pulling out the root systems embedded in the masonry, cutting the stems and roots, and the application of patented chemical biocide such as 'Glycol' so as to prevent any re-growth. The area was then made good with lime and mortar.

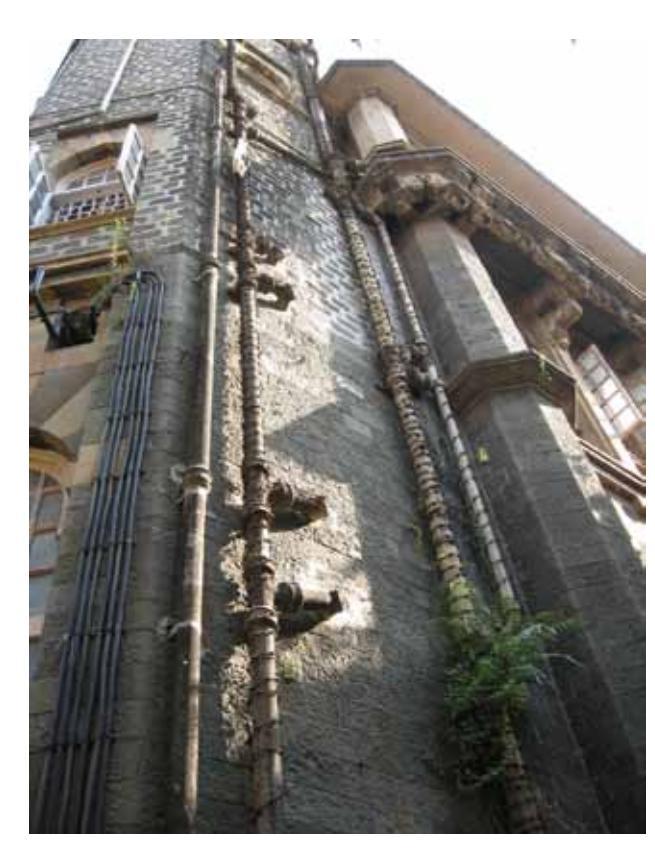
Leaking water pipes give rise to ficus growth and seepage of water into the masonry surface

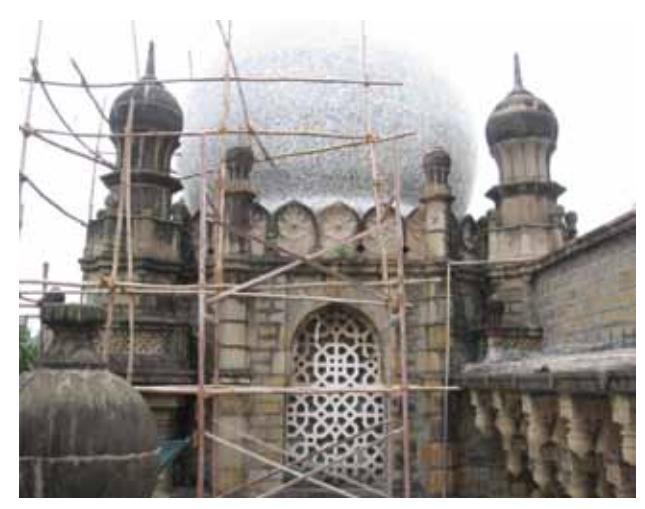
Discoloured masonry wall surface with dirt grime and salt deposits on the left and a cleaned clear surface on the right

The building is constructed using two types of stone: dark and hard basalt stone, and soft beige trackite. The stone surface had discoloured due to dust, dirt, pollution and

salt deposits over the decades and required water and chemical cleaning.

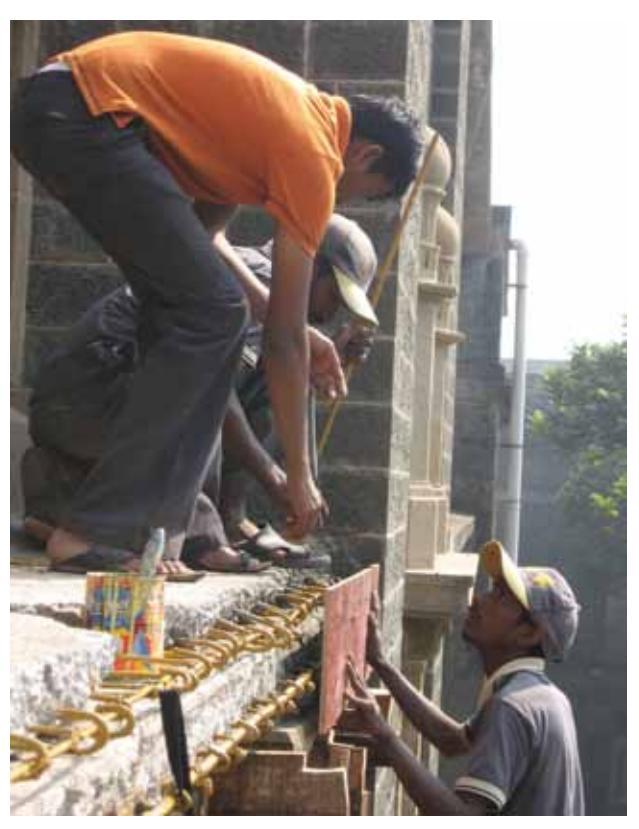
New reinforcement along the chajja and shuttering in progress for repair using acrylic polymer, cement and quartz sand

The *chajjas* (sunshades/eaves/overhang) with brackets, beams and slabs beneath were found to have deteriorated, and there was de-laminated plaster along some portions as well as exposed and/or corroded steel reinforcements. These needed to be structurally consolidated. The deteriorated plaster and concrete of the *chajjas*, beams and slabs were removed after adequate propping, the steel reinforcements were cleaned with wire brushes and rusticide, and chemical coating was applied. Acrylic

polymer, cement and quartz sand in appropriate proportion of weight were applied in layers to repair the chajja slabs after suitably shuttering along the edges.

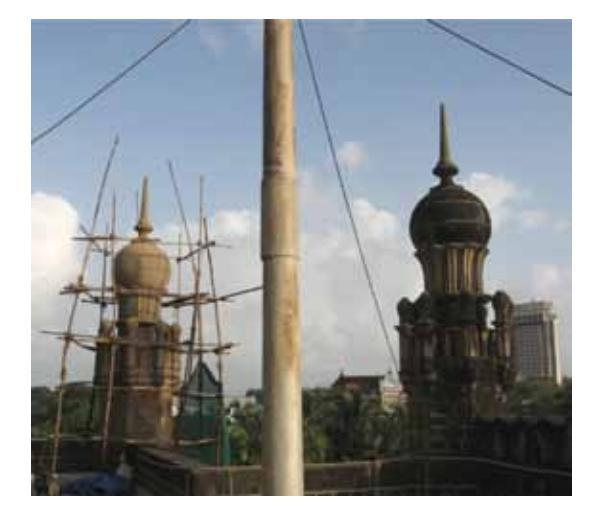
Discoloured urns and finials and other decorative elements with dirt grime and salt deposits on the right and a cleaned and repaired surface on the left

Parts of the ornamental Malad Stone urns like the finials, carved bases or the domes were either missing or damaged. Some portions of the masonry walls had small as well as major cracks and severely distressed stone sections in Kurla Basalt. New finials, stone bulbs and caps etc in matching Malad stone were carved by skilled craftsmen and fixed to damaged, missing stone guldastas, chhatris and other ornamental stone work in the urns. They were fixed with SS dowels and epoxy plugs by making the necessary grooves, keys and jointing etc with lime mortar and pozzollanic additives such as brick surkhi or white cement.

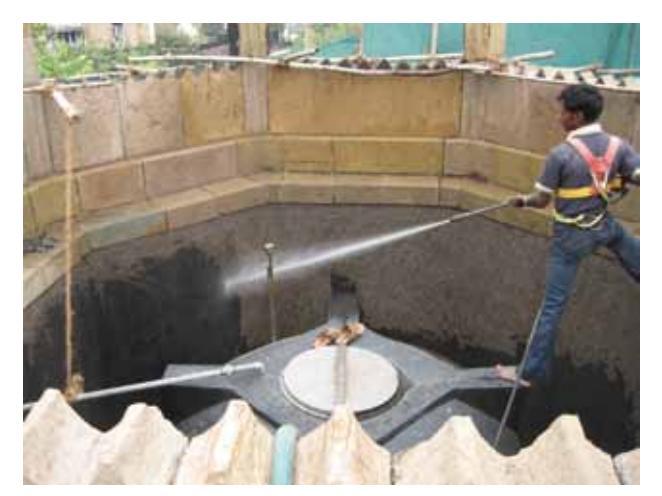
Cleaning discoloured surfaces usingthe water misting technique witha calibrated pressure pump and nozzle

façade before commencing the restoration works. The stone surface of the walls were gently cleaned with the 'Water Misting' technique employing an air water jet using a fine nozzle sprinkling system calibrated to spray a fine mist along the stone surface followed up by gentle brushing with soft nylon brushes. Chemical thinners and solvents were used to remove stubborn oil and emulsion stains on the stringer courses, decorative elements and stone surfaces. Clay poulticing was also adopted where required.

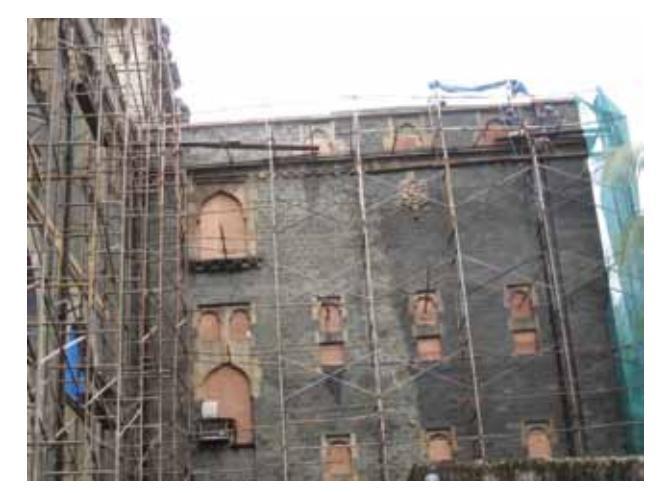
Masonry walls with ribbon cement pointing removed, re-pointing done in lime mortar, and washing using the misting technique after blocking all openings temporarily using plywood boards

The original lime mortar pointing on the stone facade had been replaced by cement-based ribbon pointing on many Temporary partitions using 4 mm thick commercial plywood were fixed to isolate the windows and other interior areas from the water misting and other works on the exterior

portions of all the walls at some point in time, which not only ruined the aesthetic value of the building but also prevented the effective breathing of the masonry walls. All the hard ribbon cement pointing was removed by raking out incongruous mortar very carefully so as not to damage the masonry, and re-pointing was done in lime mortar in a 1:3 ratio to match the original colour using traditional additive materials like katha. The missing pointing work along the entire exterior surface of the building masonry and decorative elements was also undertaken in a similar manner. Specialised tools and masking tape were used to ensure clear lines and a high level of workmanship on site.

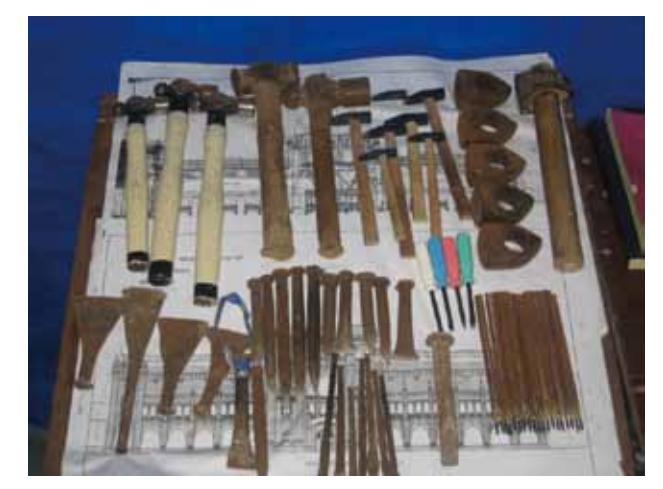
Tools used to remove the stubborn cement pointing, rake out incongruous mortar and carry out re-pointing in lime mortar

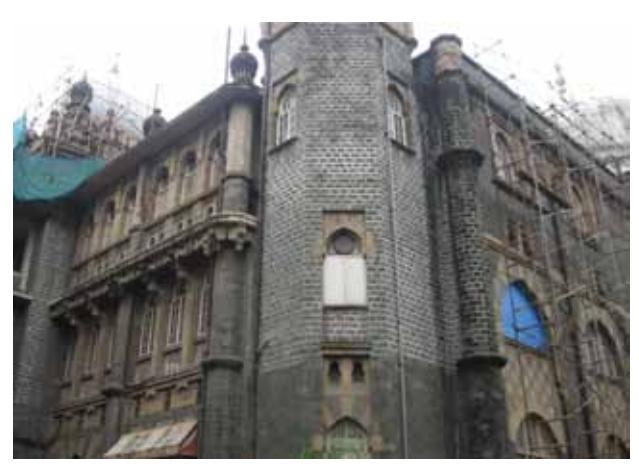
The ribbon cement pointing seen on the upper half of the corner tower has been added, while the original lime mortar pointing can be seen on the lower half

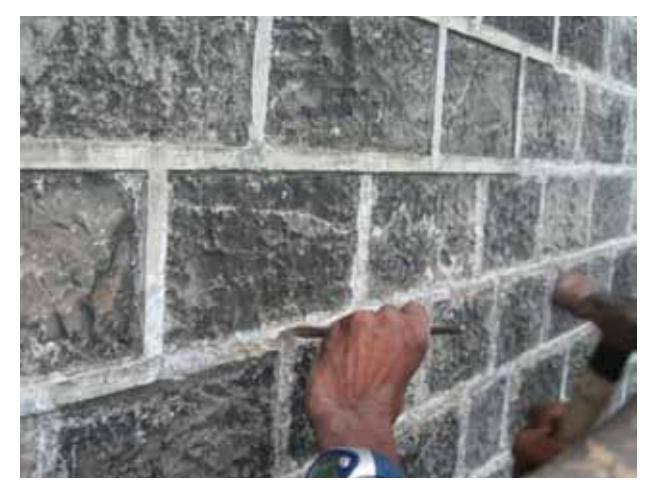
Removal of ribbon cement pointing

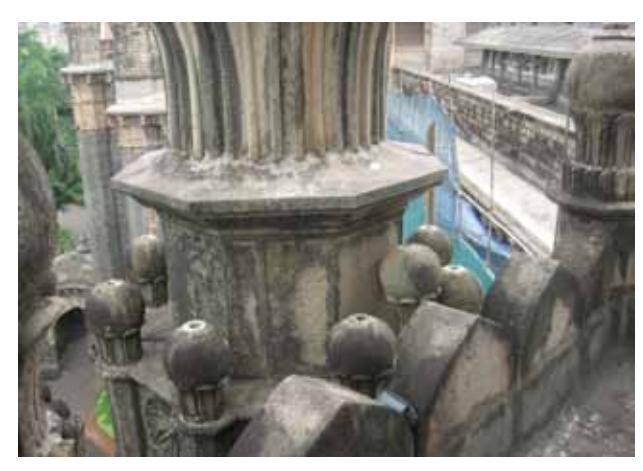
The domes and finials of the *guldastas* were in a damaged condition. The fallen domes were collected and refixed again

pieces of the masonry sections. It involved fixing new pieces of stone by using stainless steel pins threaded at the end after carefully cutting out the damaged profile.

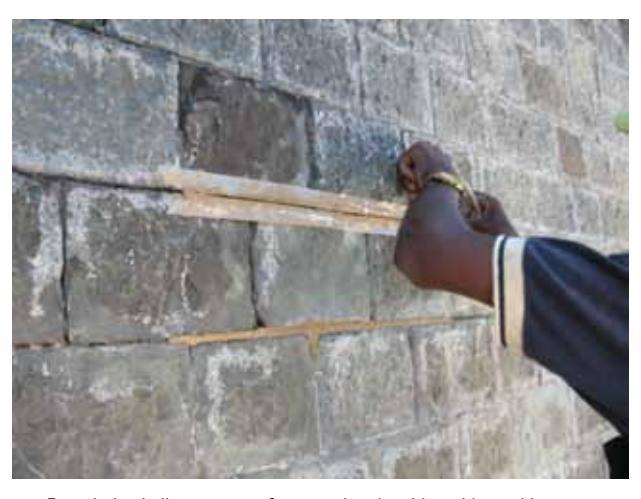
Re-pointing in lime mortar after covering the sides with masking tape

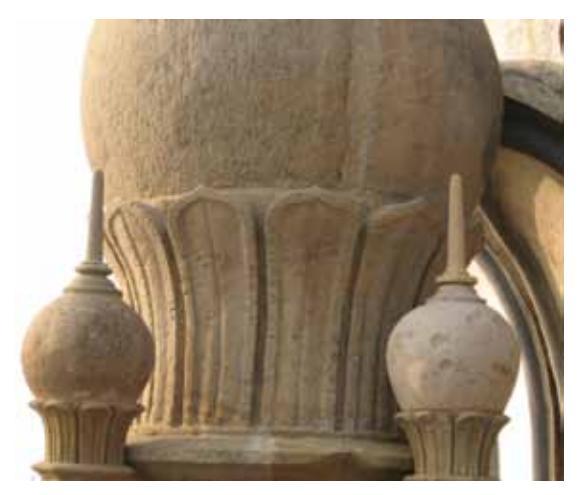
A newly carved *guldasta* dome and finial fixed beside an original and existing one

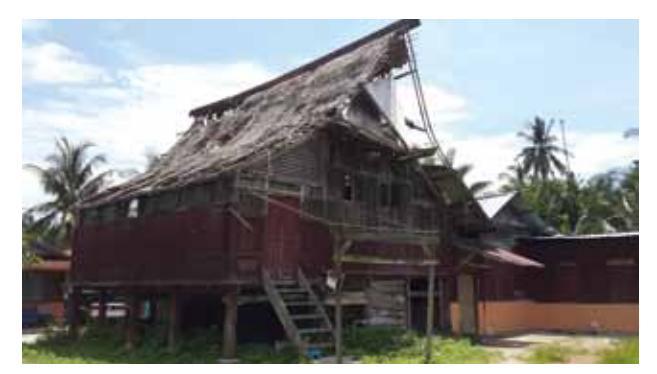
View of the Bugis house in 2014 after it was left abandoned and had deteriorated rapidly due to decayed timber structures, termite infestation, roof leakage and poor maintenance.

The Bugis house, which was left abandoned for a period of time, deteriorated rapidly due to decayed timber structures, termite infestation, roof leakage and poor maintenance. The kitchen section fell into a state of disrepair and was demolished. A new annex was constructed using bricks, timber and zinc roofing to replace the kitchen section. A dilapidation survey was conducted prior to restoration works to identify major defects of the house, causes of the defects, methods and techniques of restoration as well as relocation. Decayed timber structures, poor condition of the palm leaf roofing, decayed windows and broken lattice panels were revealed as some of the common building defects. An architectural drawing or measured drawing of the house was drawn accurately to scale for reference during restoration and relocation.

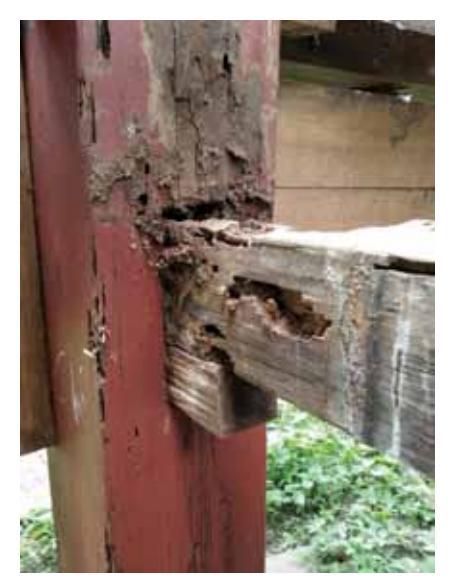
Decayed timber stilt and floor beam due to natural decay and termite infestation.

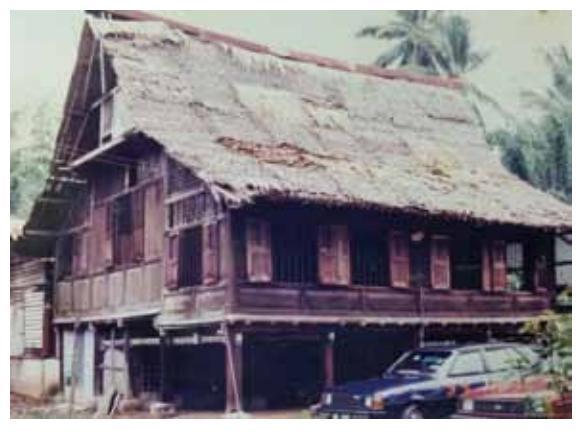
The front view of the Bugis house in 1999 revealing building defects such as a missing gable end, broken carved lattice panels and decayed thatched attap roof made of palm leaves.

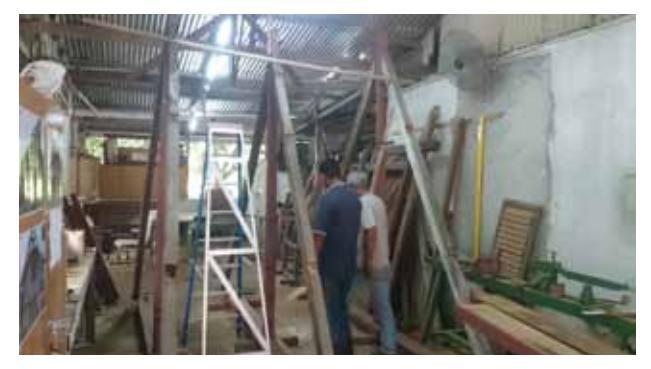
Timber structures and elements were repaired, replaced and replicated at a sawmill in Kampung Padang Jawa, Kelang, Selangor.

- i. Mark or label existing timber structures and elements for reference.
- ii. Transport all dismantled building materials from the site to a sawmill in Kelang.
- iii. Conduct timber treatment including repair, replacement and replication.
- iv. Upgrade timber species and strength group.
- v. Pack and store treated old and new timber.
- vi. Transport the timber structures and elements from Kelang to Shah Alam.
- vii. Document the treatment, transport and relocation process.

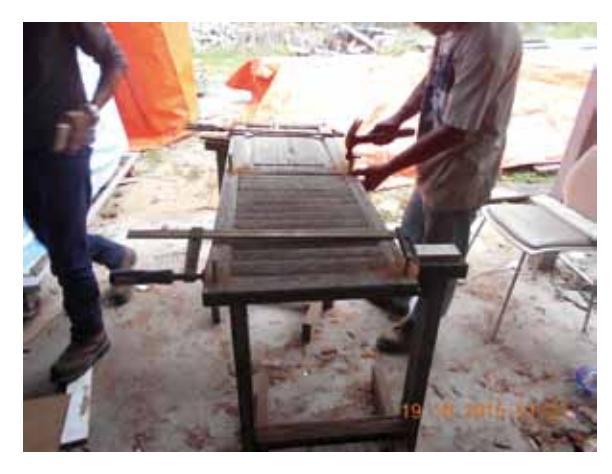
Restoration of casement window panel in progress.

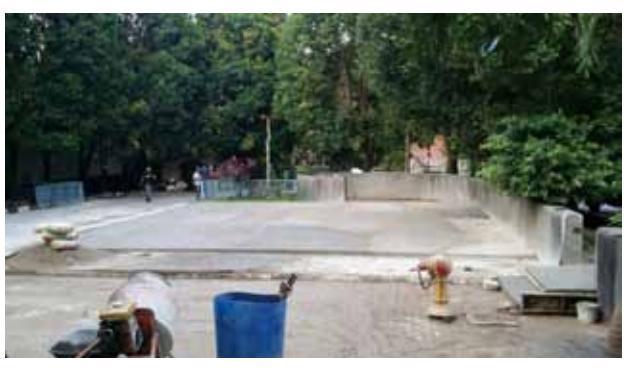
Reconstruction of the Bugis house in the grounds of the Sultan Alam Shah Museum began with the construction of a concrete-mix foundation floor to create a level surface.

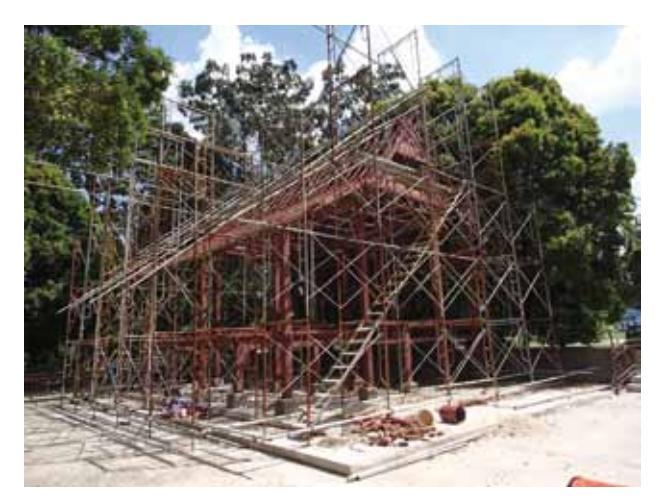
During reconstruction of the Bugis house, scaffolding was erected to support the building structures and elements, installation of new roofing materials and repainting.
